Neil P. Daugherty
Certified Fire Investigator
License #11-2602

Matter: American Electric Power / Electro Finishing Inc.
Client: American Electric Power
Claim #: C20180395220
Date of Loss: June 3, 2018 at 3:29 p.m.
Loss Location: 2817 West Lee Highway
Rural Retreat, VA 24368
Case #: 7 :19-cv-380
A.R.C. #: 1811056-C

INVESTIGATIVE SUMMARY

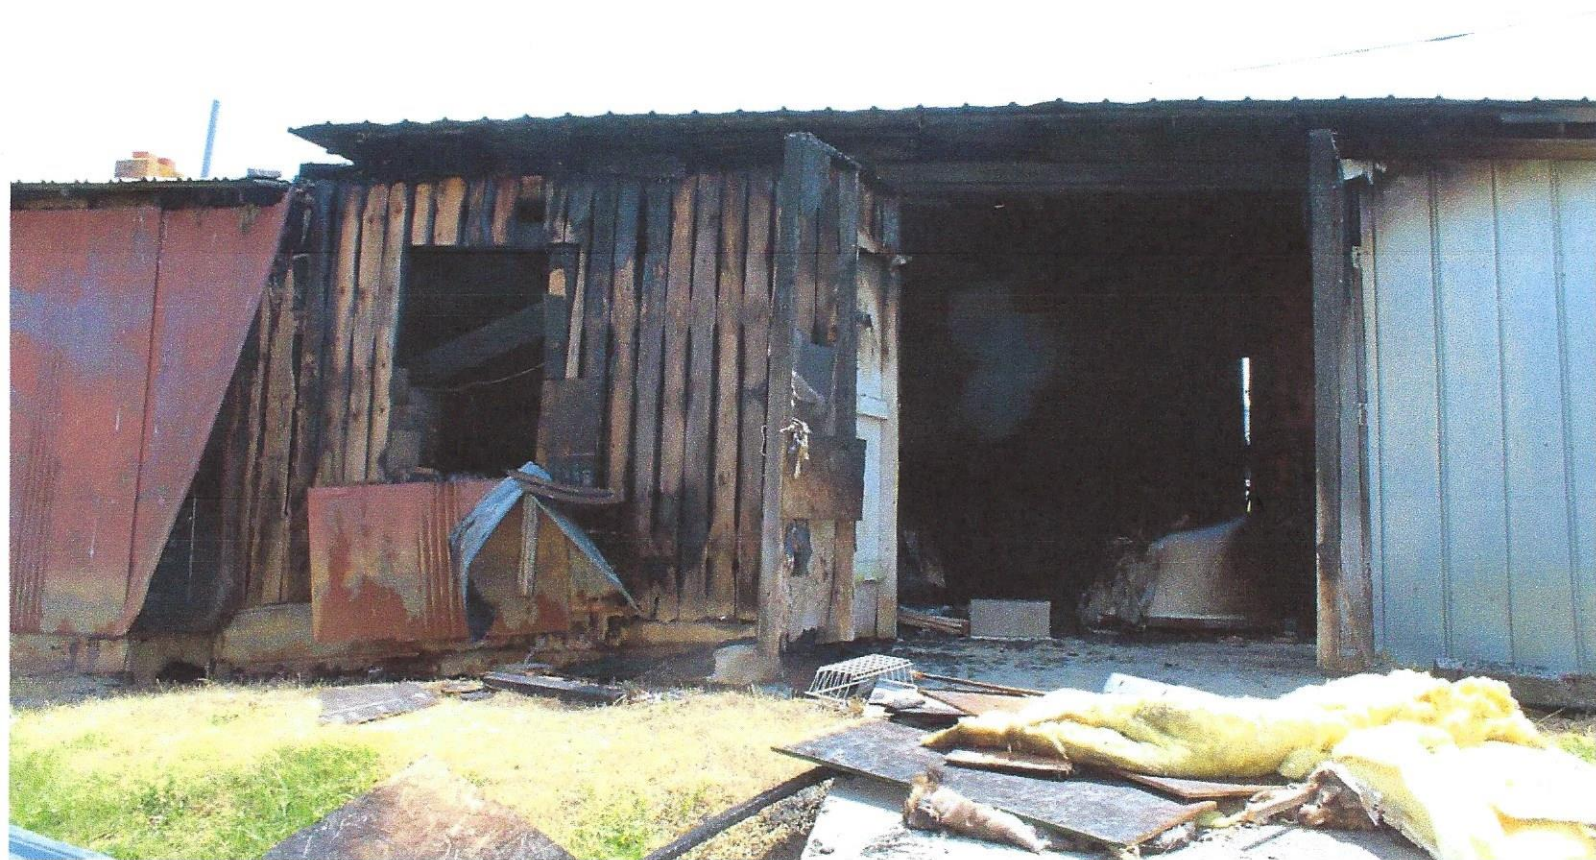
Page # 51

- 51. Exterior (rear) -most extensive damage at the SW corner of the shop.
- 70. Shop (rear) -most extensive damage & fire travel from SW corner.
- 104. Shop (rear) -most extensive damage & deepest char in SW corner.

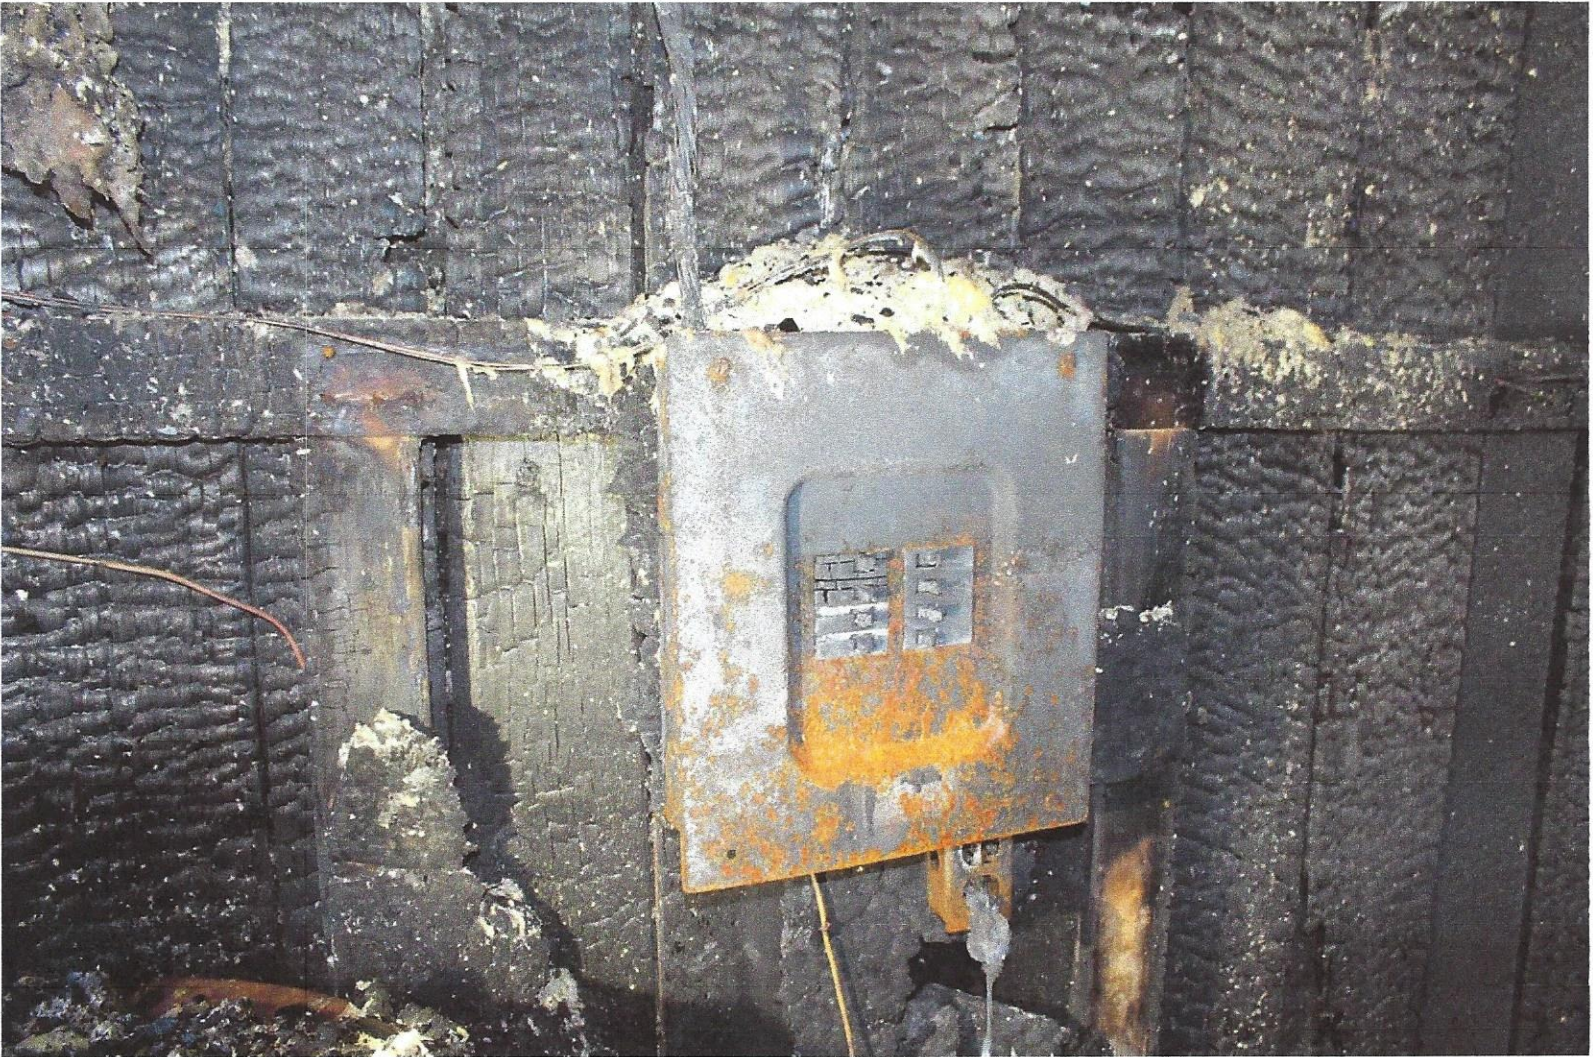
- 115. Shop -no penetration for main breaker & low oxidation on panel cover.
- 119. Shop -Aluminum conductors attached to buss bar (no main breaker).
- 125. Shop -Heaviest oxidation in base of panel (consistent w/pre-fire moisture).

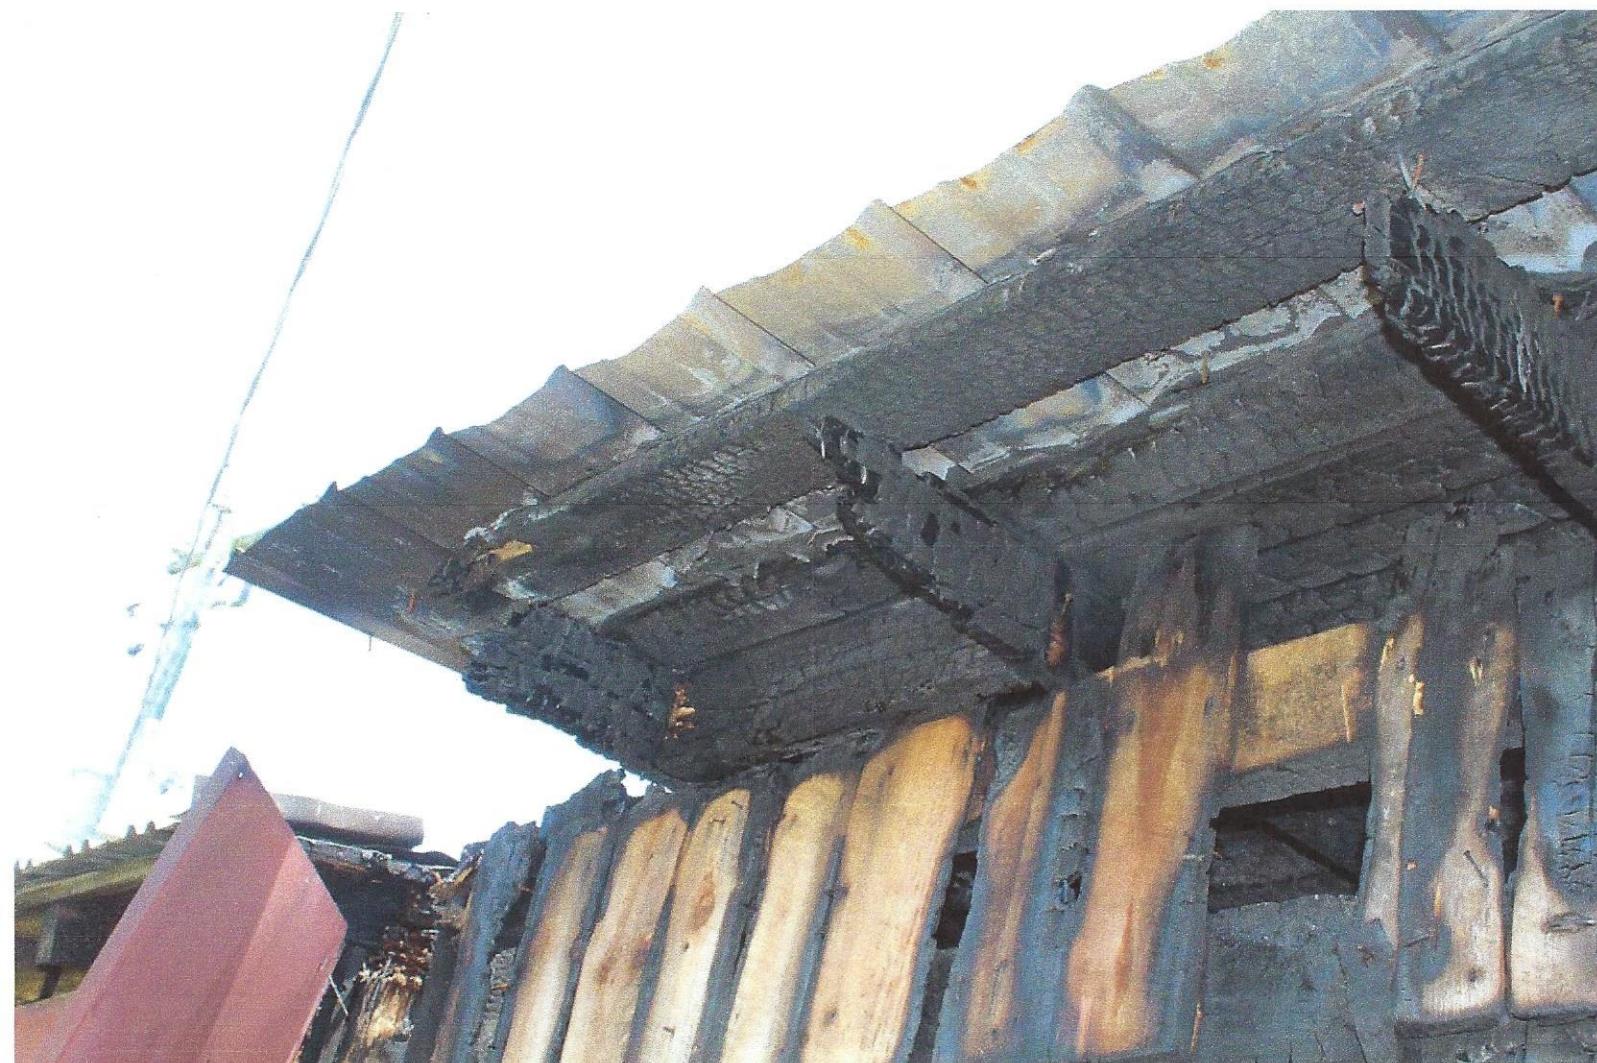
- 136. Exterior (rear) -Most extensive damage to roof system (sheathing/joist/siding).
- 137. Exterior (rear) -Aluminum conductor remains in SW corner of the shop.

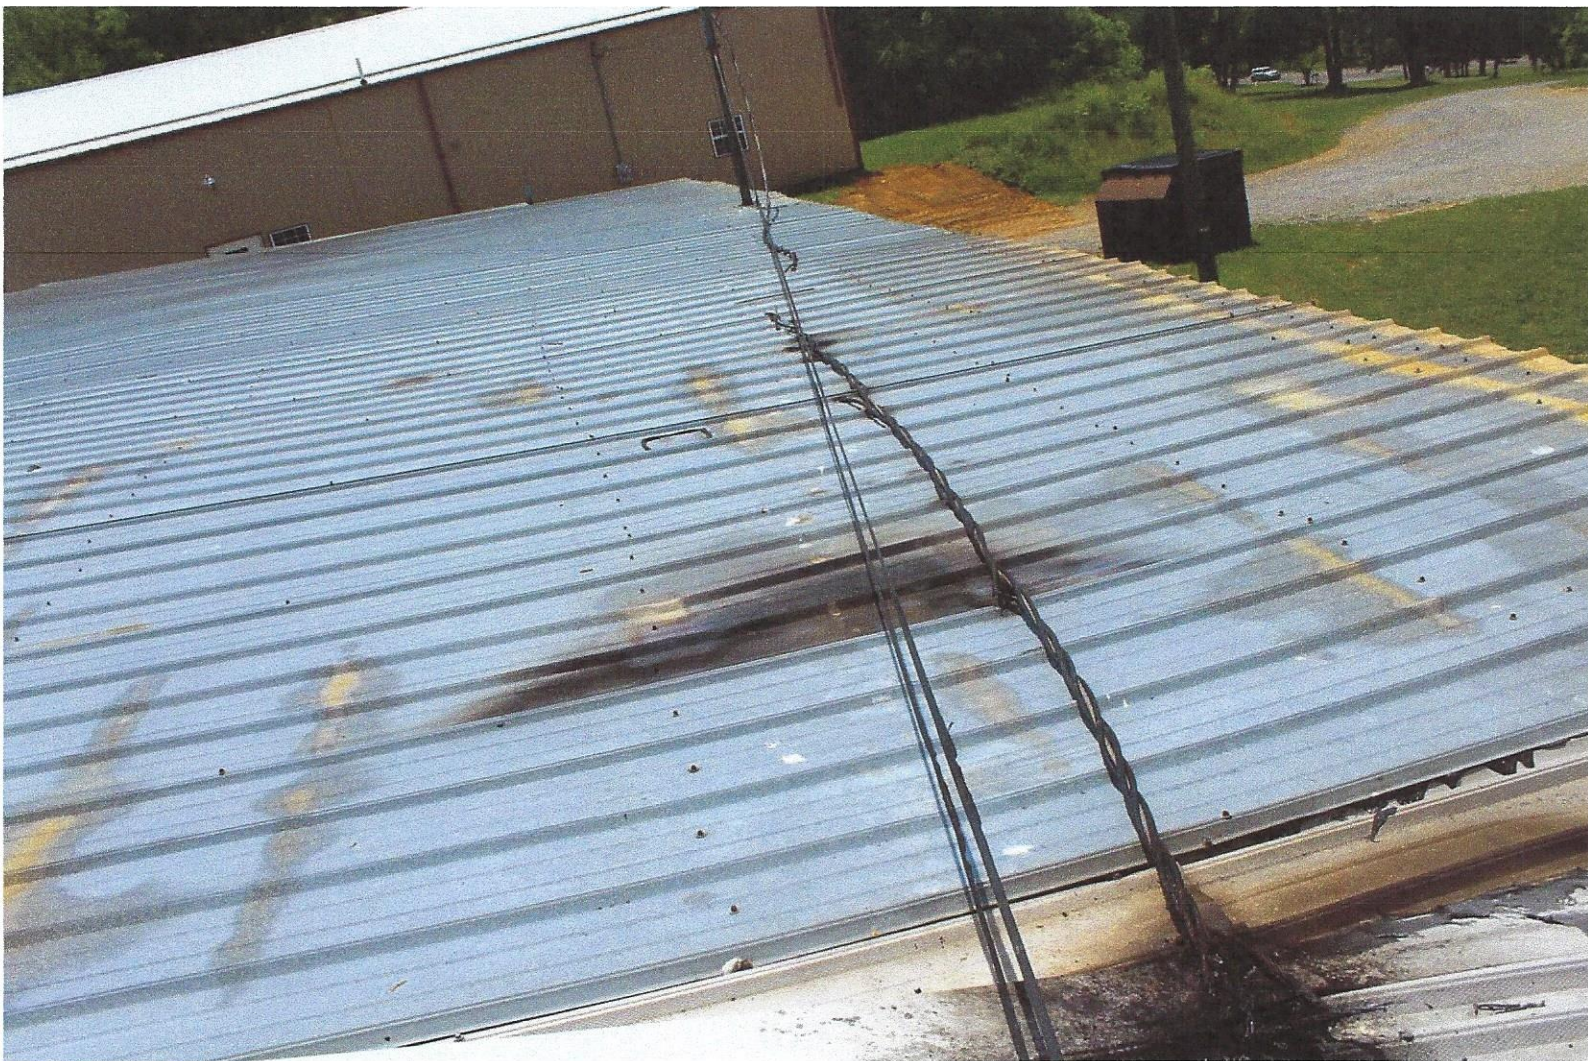
- 146. Roof -Numerous burn patterns (between slatted sheathing) remote from triplex.
- 167. Roof (SW corner of the shop) -Left to right fire travel on (4x4) studding, heaviest charring & oxidation on left side of (4x4) studding, & pitting with metal transfer on nail.

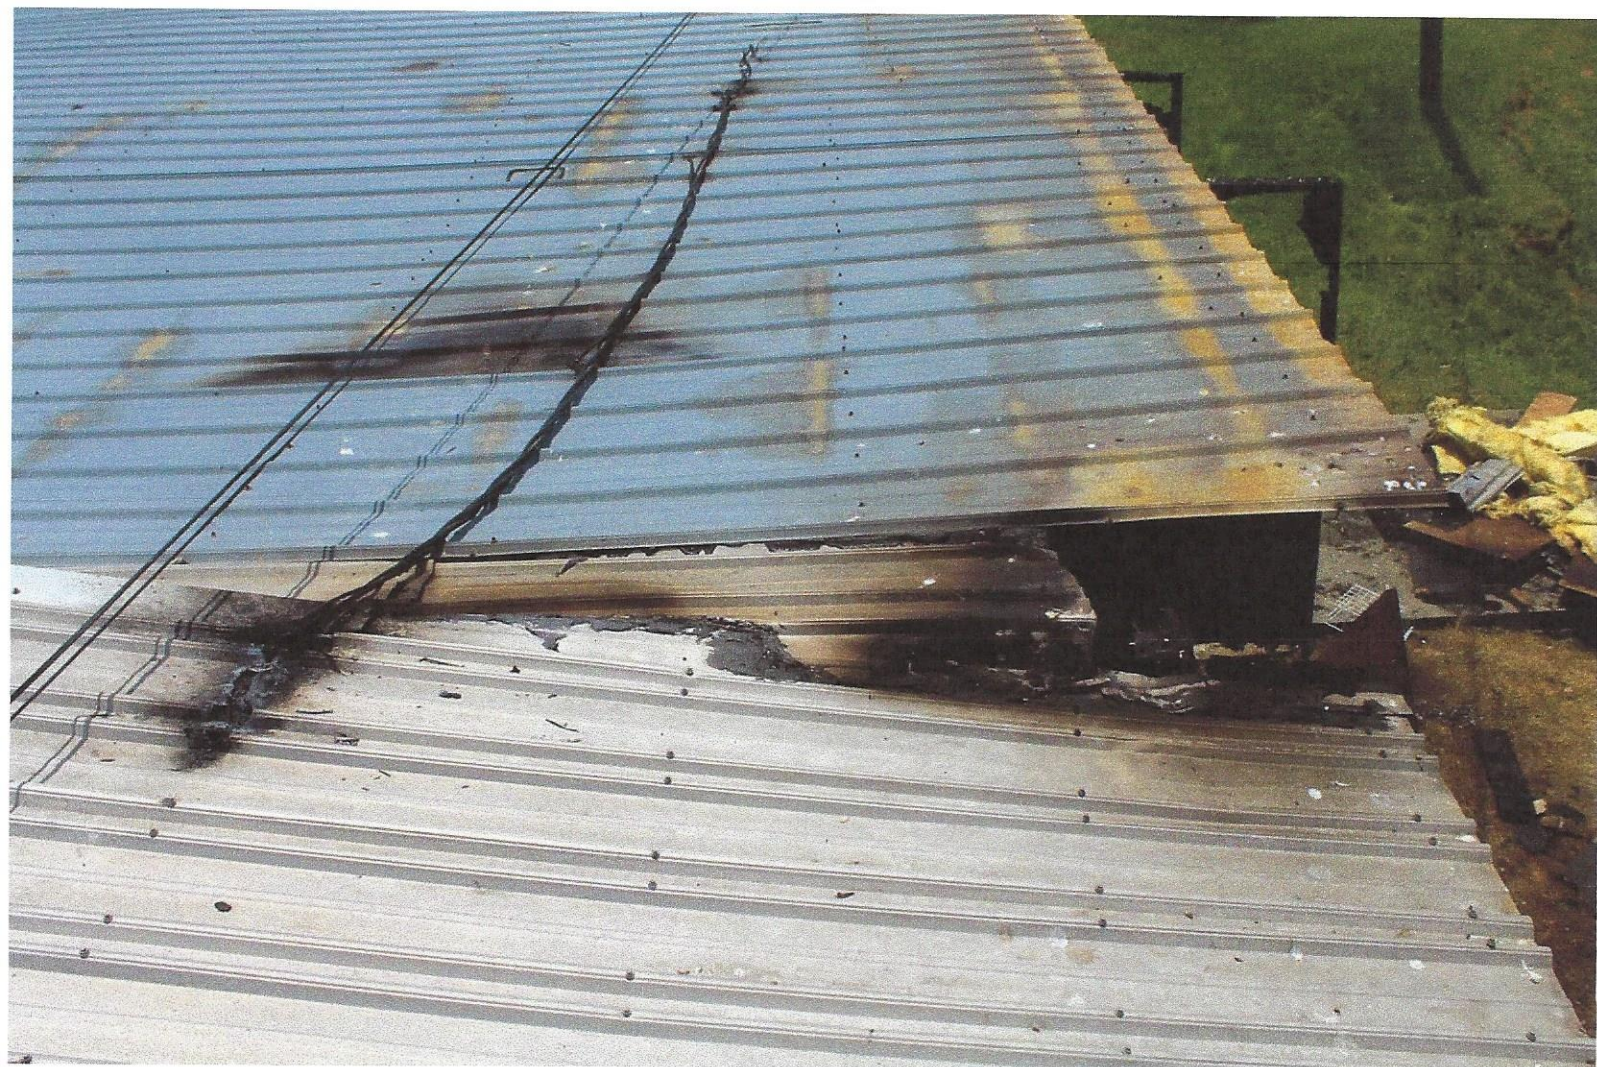
Page # 168

The damage to the triplex drop occurred late into the progression of this fire. The expanse (length) of the triplex drop located above the roof is unknown. The ambient temperature 85°, the flash-over fire beneath the metal roof, and the venting fire with its thermal column within 6 ft. of the triplex caused the triplex to expand, stretch and sag. This allowed the triplex drop to come within close proximity of the metal roof and its mounting screws causing arcs in multiple spots. The minimal damage to the metal roof and mostly undamaged remains of the triplex support this theory (page #168).

- 168. Roof -Most severe intense heat damage to metal roofing remote from triplex.
